## **Report of Sampling and Analysis Results**

**Davisville Army Housing Units  
North Kingstown, Rhode Island**

August 1990

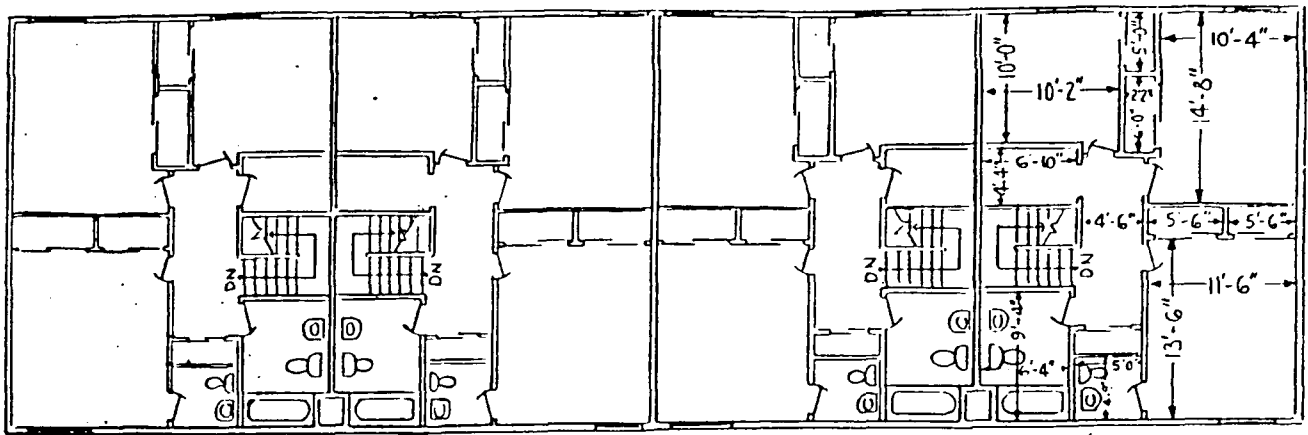
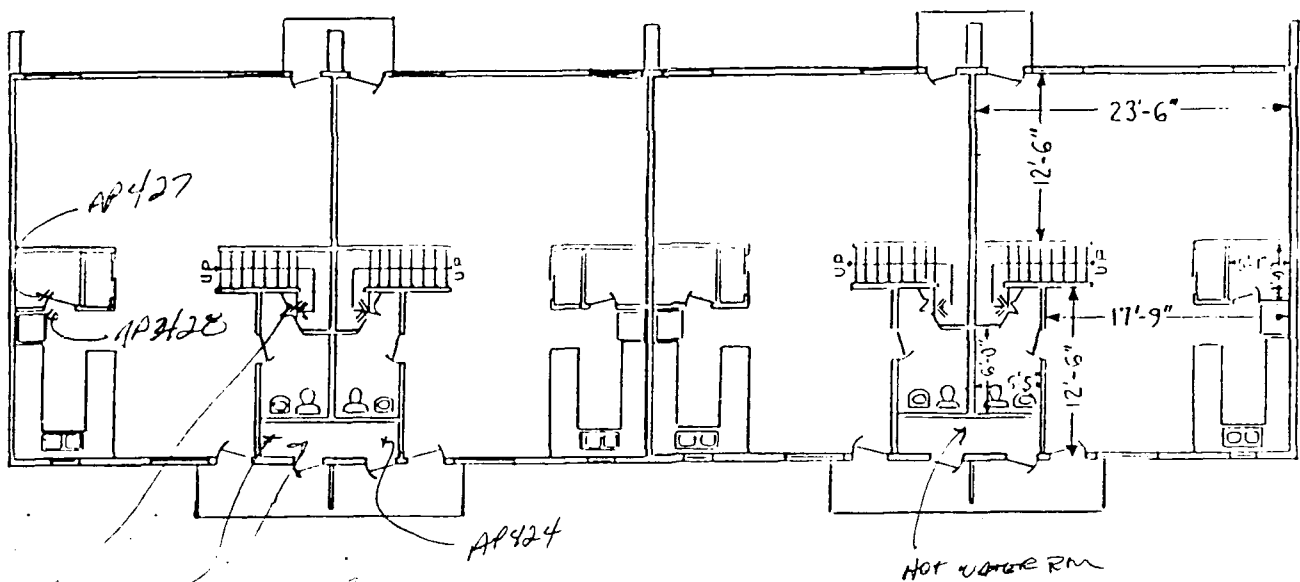
59 NAVY DRIVE

This is a two 3 bedroom, 2 bath home with tan aluminum siding. There are no floor vents present. The furnace room has residual air cell type insulation in the foundation. There are 3 types of floor tile present. There is spray on (white decorative type) in all the rooms. The roofing shingles and felt are suspect. This is a type C, 3 bedroom town home. It was chosen because it is vacant and based upon available drawings, maintenance records, and discussions with maintenance personnel. This is one of three types of homes present. It is

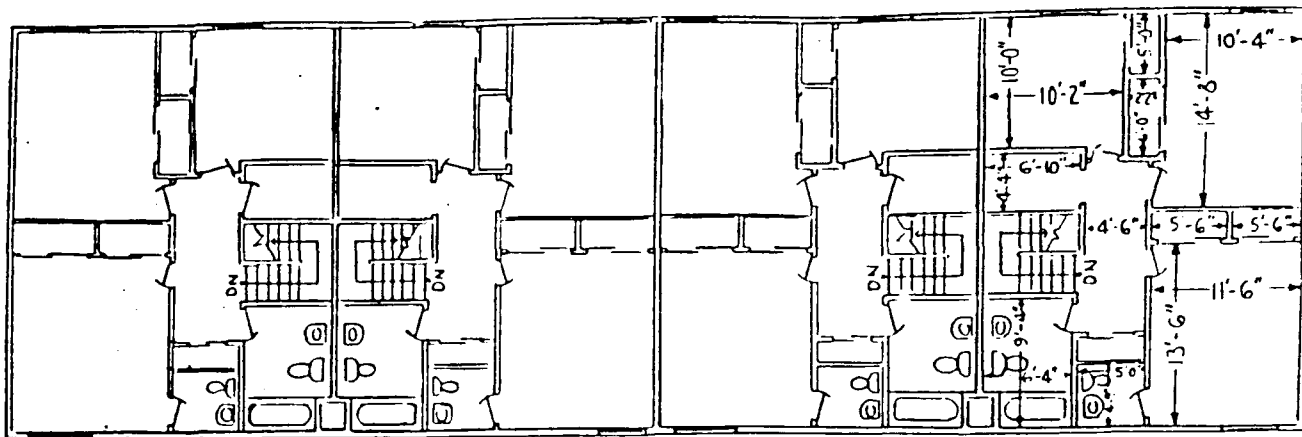
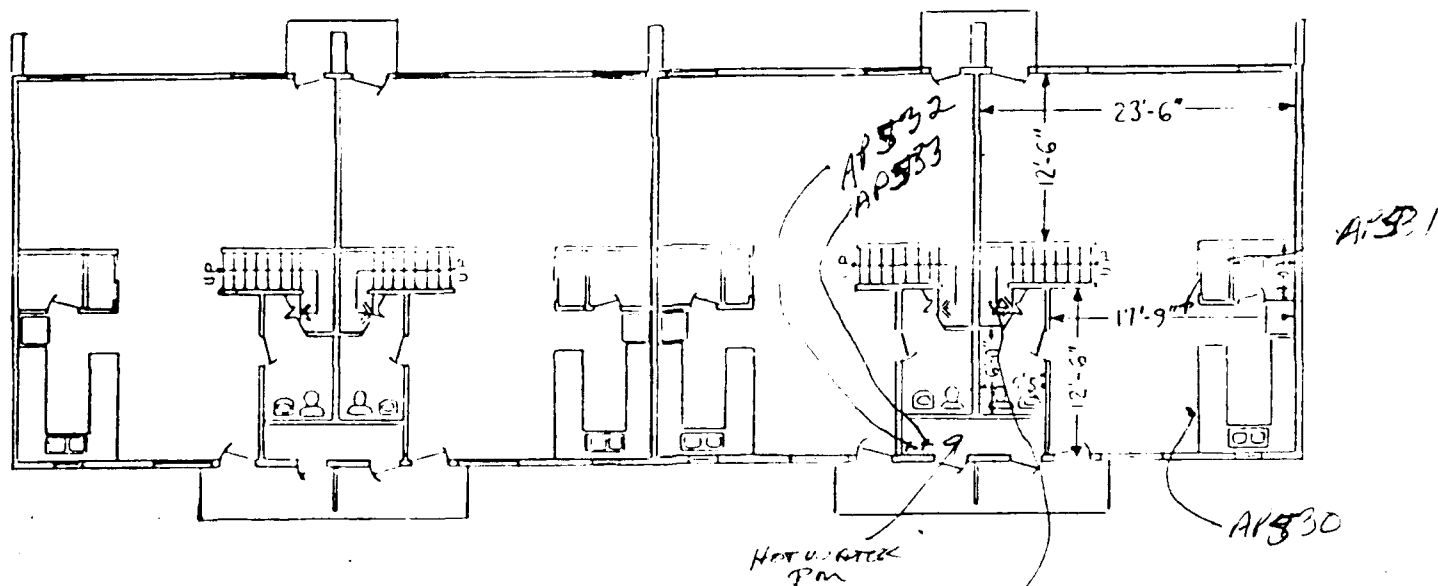
48 NW 1/4 DK.  
DAVISVILLE, RI

NOTE NO.	NOTES/REMARKS/COMMENTS/DETAILS/OTHER MATERIALS, QUANTITY, ETC.
<u>01</u>	<u>12x12 white with brown floor tile in first floor bath only.</u>
<u>02</u>	<u>12x12 floral floor tile in kitchen only</u>
<u>03.</u>	<u>9x9 purple floor tile in living/dining and all three bedrooms.</u>
<u>04</u>	<u>in cell type insulation coming up from the foundation, it has been cut flush with the foundation. it is <del>4"</del> less than 4" size.</u>

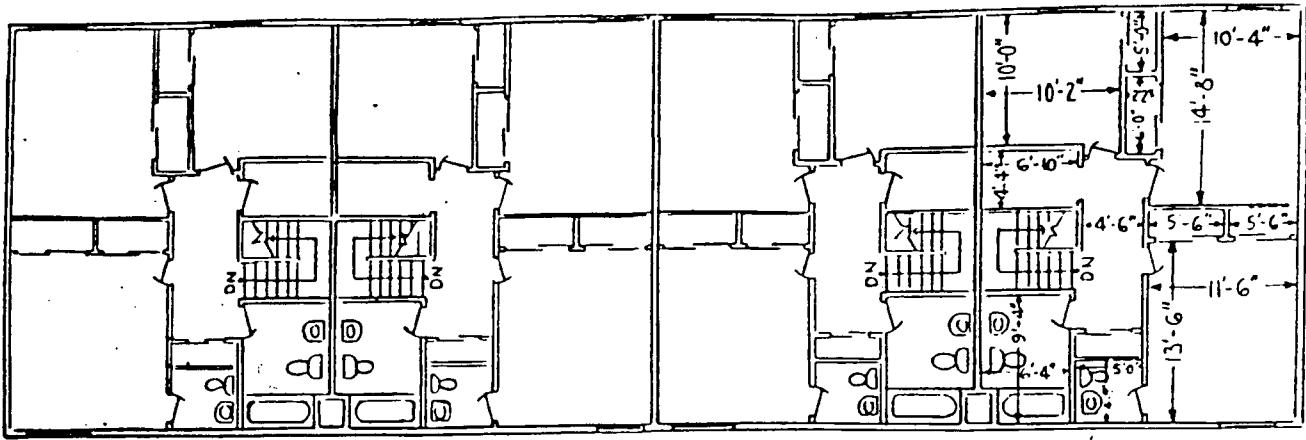
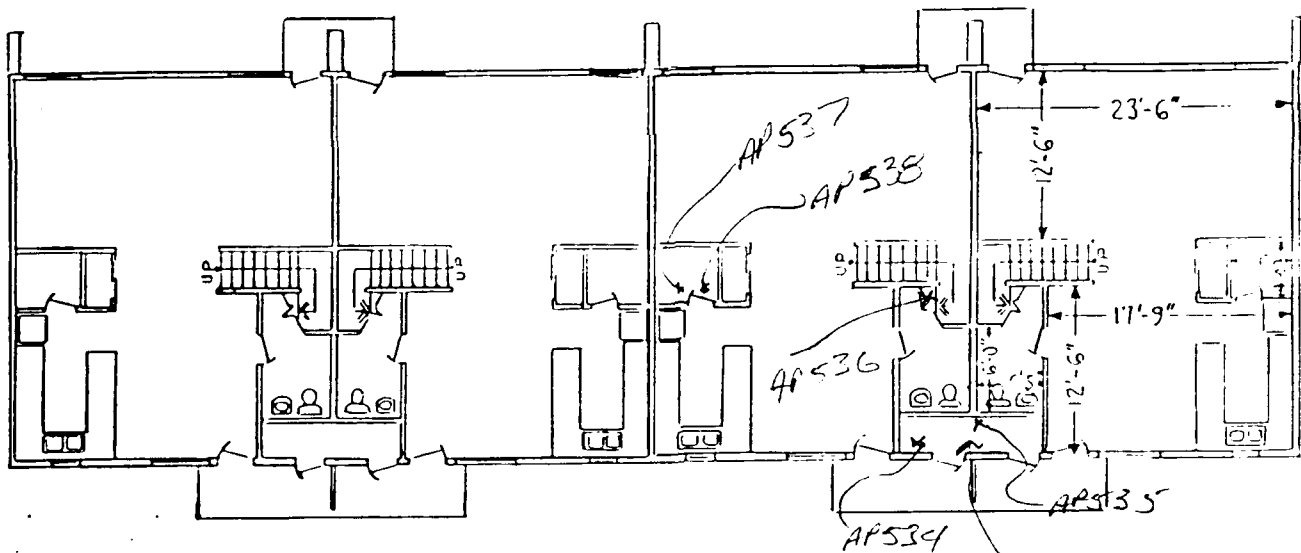
39 NAVY DRIVE  
DAVISVILLE, XI.

NOTE NO.	NOTES/REMARKS/COMMENTS/DETAILS/OTHER MATERIALS, QUANTITY, ETC.
<u>01</u>	<u>air cell type insulation that comes up through foundation, but is cut flush with foundation. Less than 4" size.</u>
<u>02</u>	<u>12x12 floral pattern floor tile in kitchen + 1st floor bath.</u>
<u>03</u>	<u>9x9 purple floor tile in all rooms except 1st floor bath and kitchen.</u>

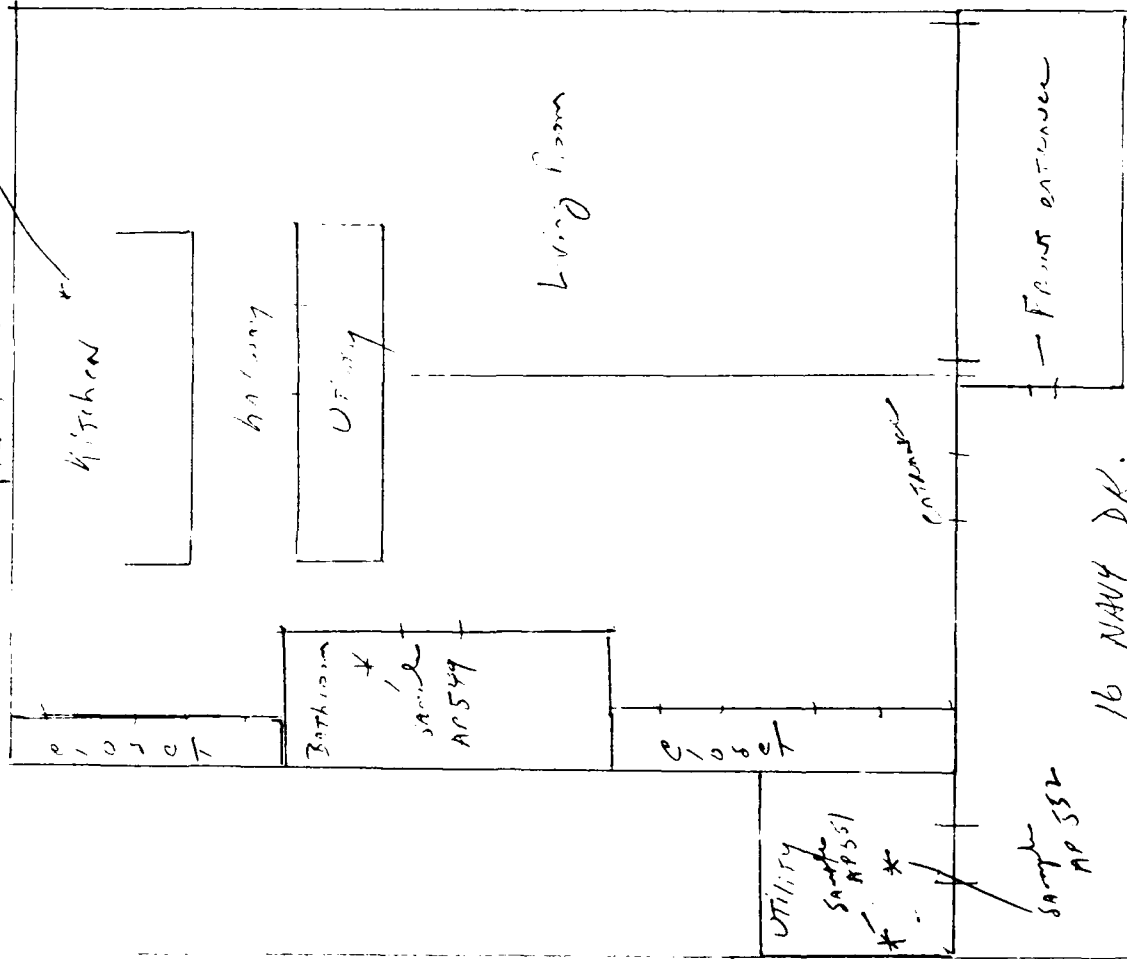
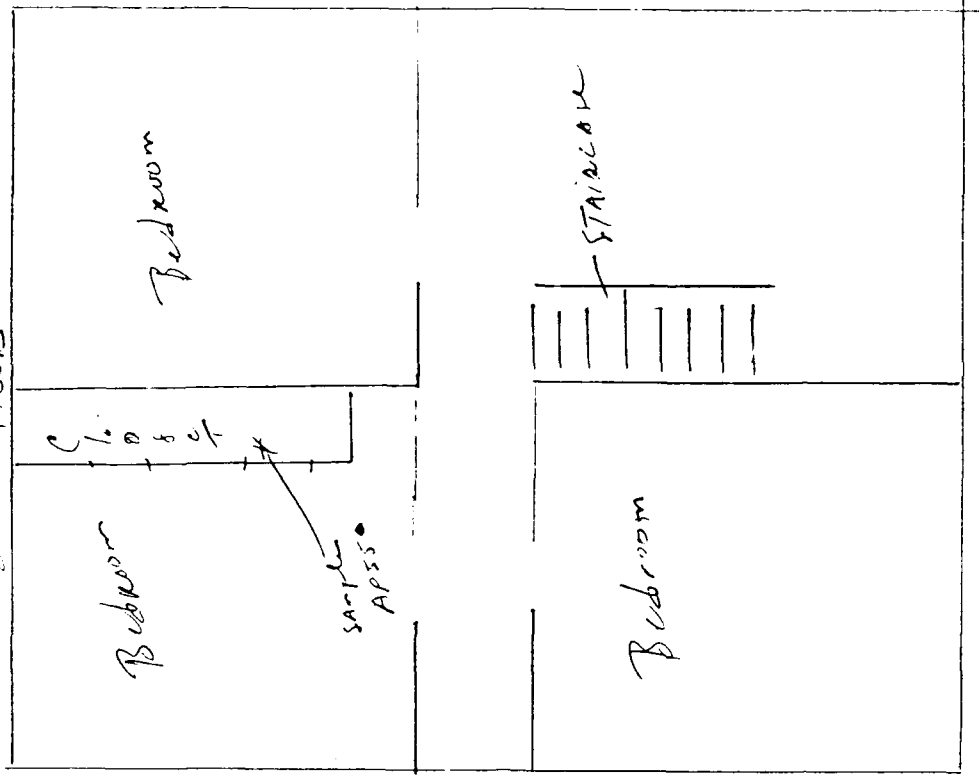
16 NAVY DR.

NOTE NO.	NOTES/REMARKS/COMMENTS/DETAILS/OTHER MATERIALS, QUANTITY, ETC.
01	12x12 floral pattern <del>floor</del> floor tile in kitchen only.
02	12x12 white in 1st floor bath only
03	9x9 black floor tile in all rooms except kitchen and 1st floor bath.
04	air cell type insulation <del>from</del> coming up from <del>floor</del> foundation, but it is cut flush with floor. It is less than 4" size.
